## Overgate Mealsgate – Statement of Changes due to Structural/Building Regulation issues- February 2025

Whilst permission was obtained for various works during the construction a greater understanding was gained revealing structural issues or building issues conflicting with current building regulations which required some minor amendments: -

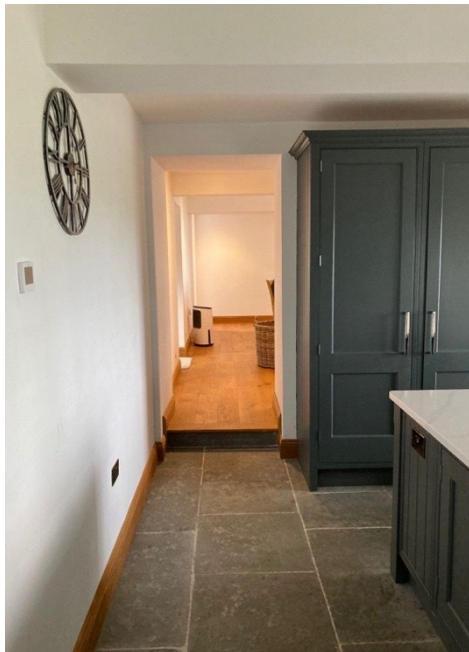
Permission was given to insulate and replace floors and with the above engineers comments, to avoid walls collapsing and to comply with todays building regulations it was necessary to raise the floor slightly in the living room and dining area which also helped with damp issues.

*View from kitchen - Step up to dining and living area*

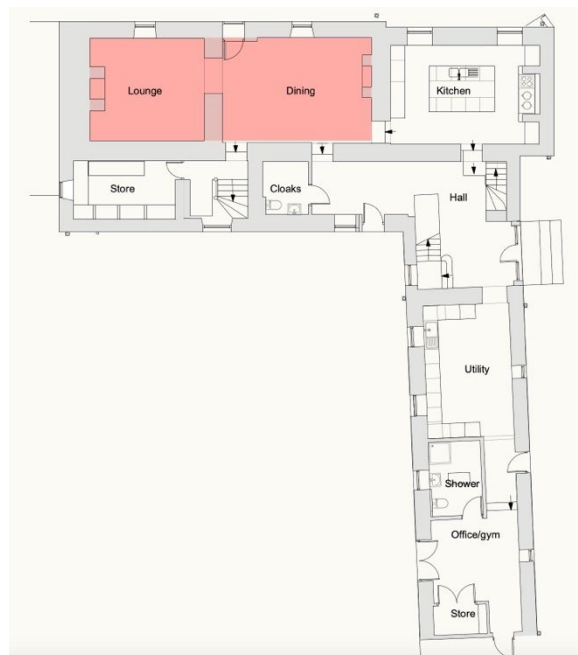
With this trial holes were excavated against the main house walls which identified the walls to be founded at a shallow level. Significant underpinning would have been required to facilitate the new ground floor construction. The walls are formed in random stone rubble fill and appeared loose in many locations; local collapse was a real potential should the walls be undermined. The engineers opinion was to lift the floor level to allow the new floor construction to be achieved without undermining the existing structure. In addition in some areas external ground levels were higher than internal floor levels

*Ground floor Raised floor area*

*See WDSInspection report- item 1*

*Floor condition*

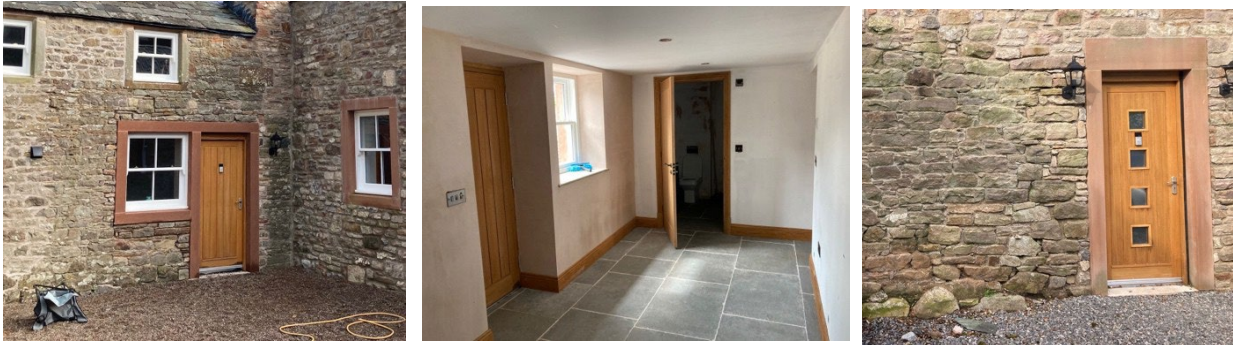
The external level access entrance to the barn and utility area leads into the link building and into the upper ground level of the farmhouse where the accessible toilet is located. Due to existing ground levels this results in external steps to the main entrance and a low floor to ceiling level under the first floor balcony (2.13m).

Level access to rear door and office door leading to level access to toilet

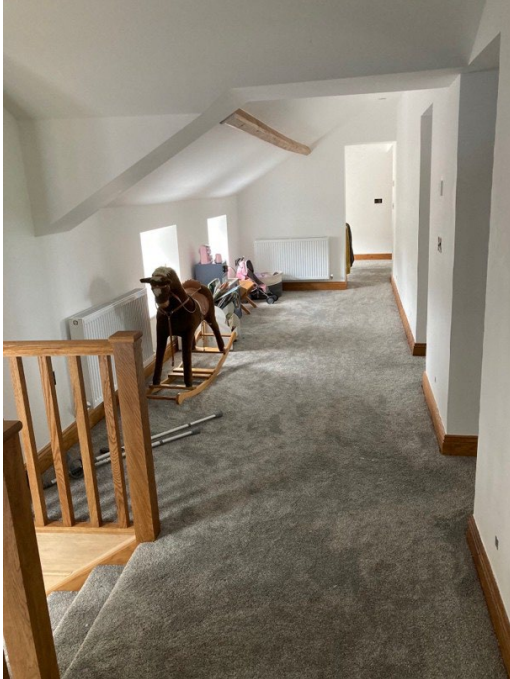
1 - Light and airy First floor Landing area

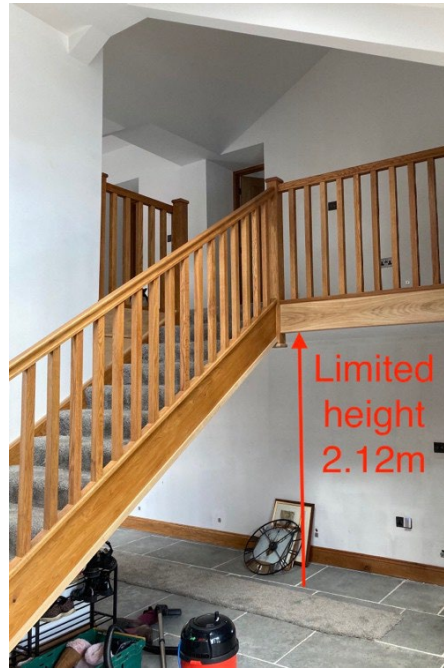
Approval was given to remove bathroom, wc and stores in the sloping area of roof which had limited headroom to allow a more open plan and brighter landing area however the approval did show a step down on the landing. As noted above headroom at ground floor under the landing is low (2.130m) and a step down on the landing would reduce headroom to less than 2m which would be unacceptably low.

2 - Limited headroom under landing

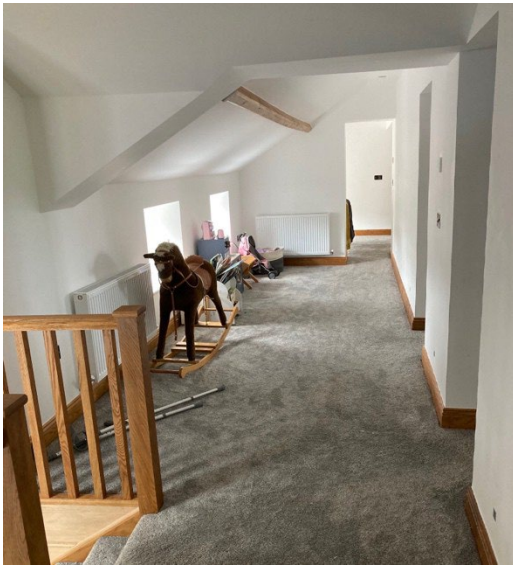
With the removal of all other bathroom/store walls in this area to provide an lighter/brighter landing area (see photo 1) the non structural wall was removed to continue the open plan theme and not felt to be detrimental providing light at the head of the stair and an open view.

*Head of stairs with open view to landing*

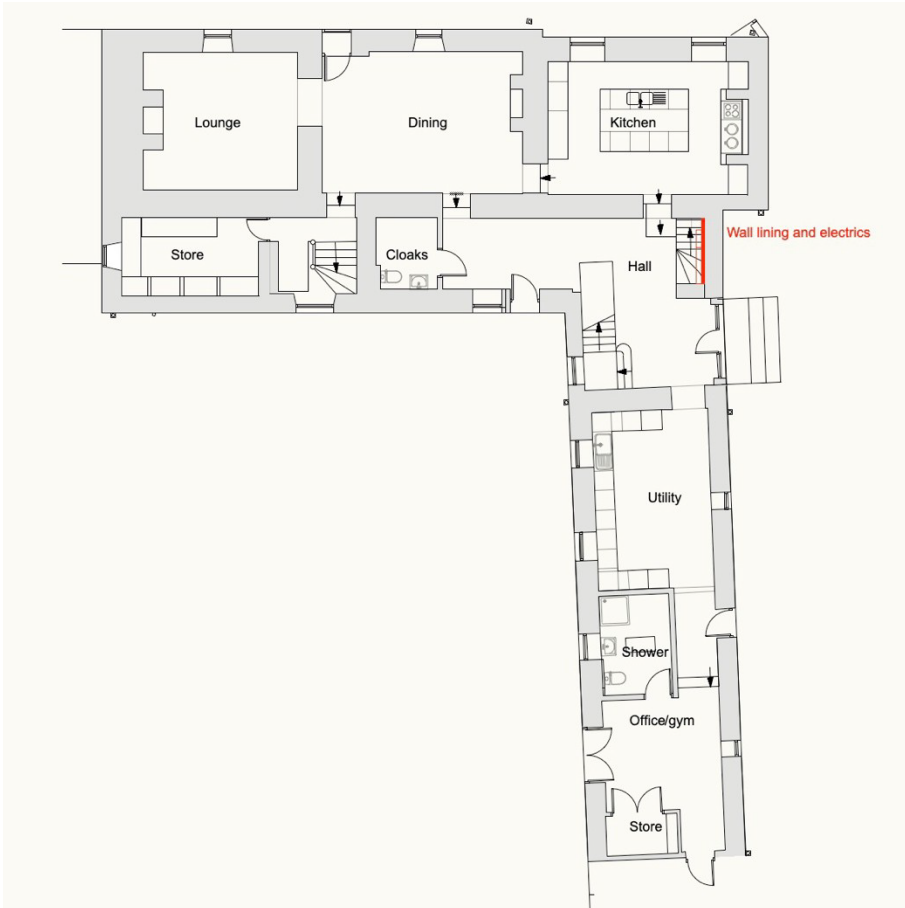
*Illustration 4 – Lining to wall and proposed*

The one area not shown was the external section of wall adjacent the stone staircase. This wall however contained the existing electric meter and fuse board to which all circuit wiring returns which originally together with the stair was hidden in a modern partition enclosure with sliding door. It was agreed the feature stone stair should be open to view due to its historical significant and remain a feature in the building. With no wall lining the area of north facing wall is a cold bridge and there was found to be rising damp issues.

Wall lining and electrical equipment – all other external walls lining approved

Therefore in accordance with BRegs Document C Para 5.10 – diagram 11 the lining of the wall is necessary to prevent damp issues. This has the huge benefit of creating a service void to hide all wiring to and from the existing circuit board. There are further plans to enclose all electrical equipment in a close fitted wall cupboard above the stone stair which will be subject to a further LBC application.

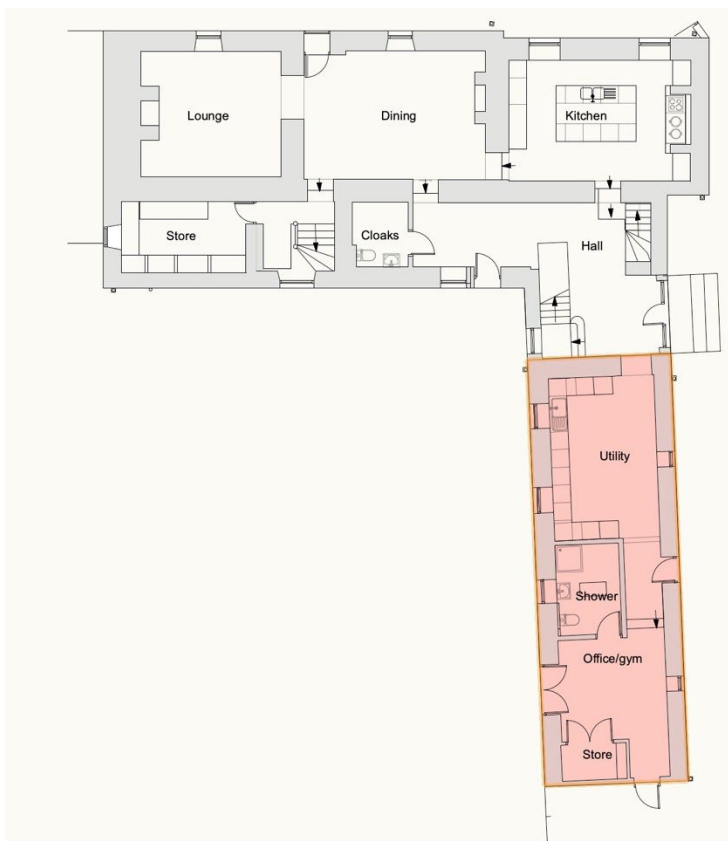
In addition the original slightly undersized roof rafters needed replacement due to rot with slightly taller rafters specified by the engineer and given approval. The taller rafters also allowed thicker insulation to be incorporated in the roof to reflect current thermal regulations in the building regs. (Building Regs Document L Table 4.2 Limiting U values in existing buildings)

*Illustration 5 - Window lintel and truss padstone above windows outlined in red*

*Single storey barn  
Timber trusses replaced due to poor condition*

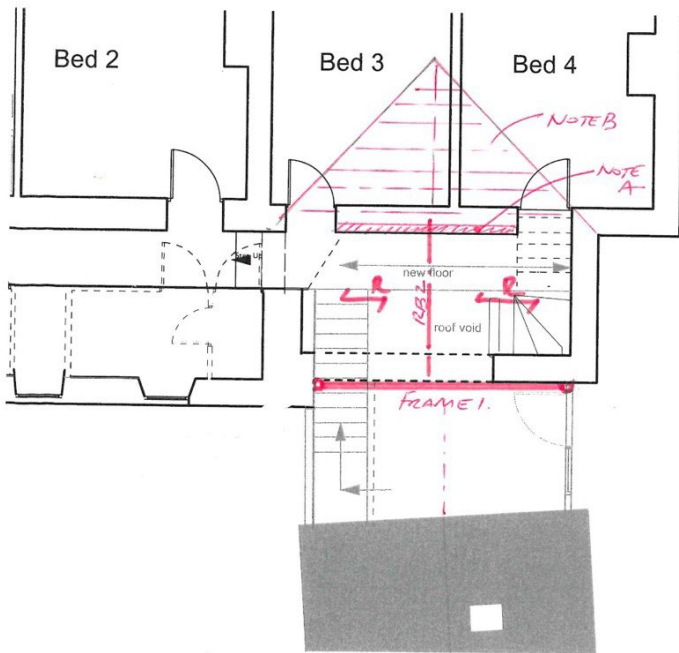
Illustration 6 –View of Entrance hall and staircase  
Steelwork spring point set out by door head height (highlighted in the red circle)

With the development of the engineers steelwork proposals for the link there is a increase in height of a short section of the eaves on the two storey extension however ridge height as been maintained in this area. As can be seen in Illustration 6 the steelwork for the link springs from the head of the door into bed 3 and was kept as low as possible appreciating the sensitive nature of any extension.

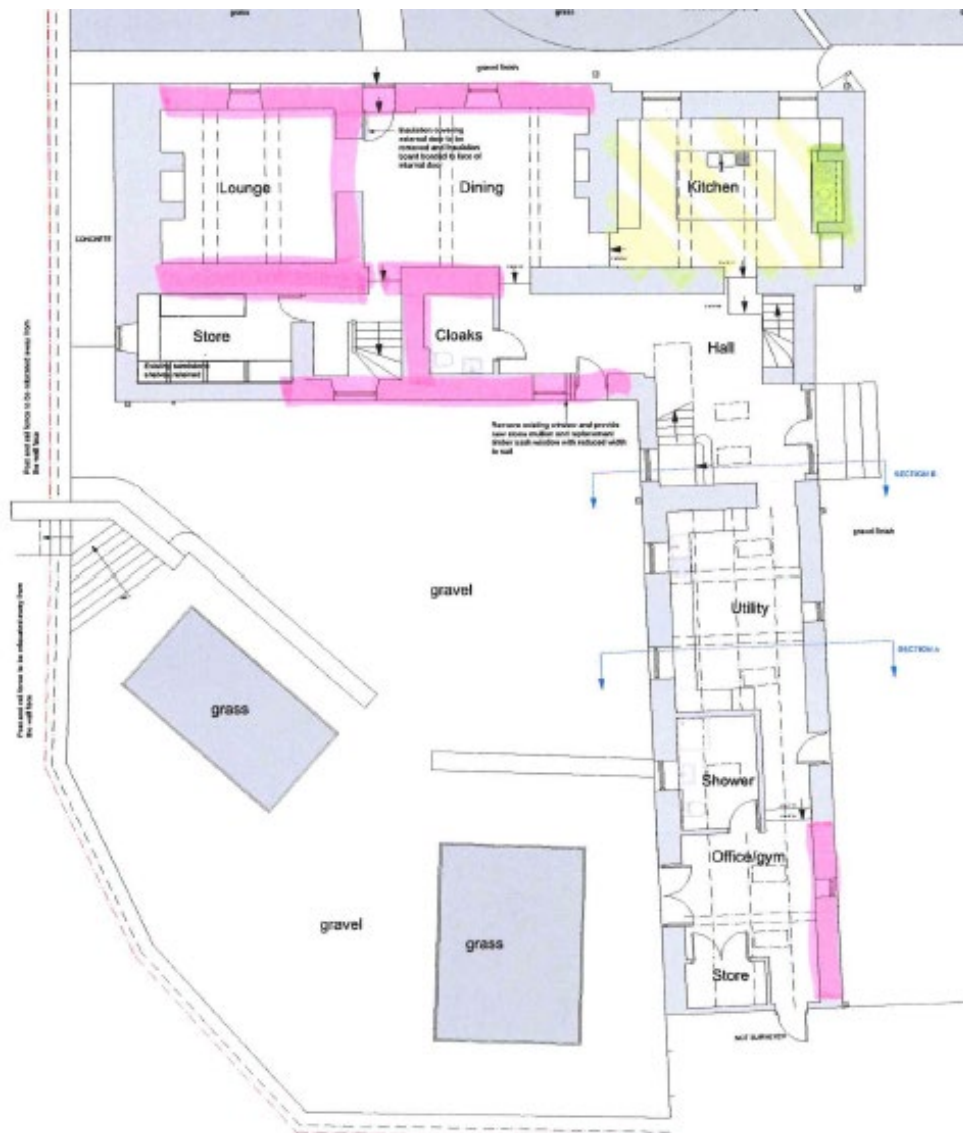
1. The ground floors were in a poor condition and needed replaced to allow insulation and a DPM to be installed as per the Architects specification. With this trial holes were excavated against the main house walls which identified the walls to be founded at a shallow level. Significant underpinning would have been required to facilitate the new ground floor construction. The walls are formed in random stone rubble fill and appeared loose in many locations; local collapse was a real potential should the walls be undermined. Our opinion at that time was to lift the floor level to allow the new floor construction to be achieved without undermining the existing structure.

2. The joisted floor over the kitchen was in an inadequate structural condition. The joists comprised 75mm deep timber sections which spanned between the house walls over intermediate timber beams. The joists bounced significantly when walked upon and the timber beams had been affected by rot especially where set into the main walls. In our opinion the floor structure needed replaced with a suitably designed structure.

3. The left hand chimney breast was not bonded into the gable wall and had rotated away from the wall. The masonry forming the breast was also in a poor condition which was revealed when the old plaster was removed. It was our opinion that the breast structure was unsafe and should be removed.

Plan to identify the points in the structural letter from WDS. Point one is pink, point two is yellow and point 3 is green.
