## VISUAL STRUCTURAL INSPECTION

**BARN  
LANGRIGG HALL  
LANGRIGG  
ASPATRIA  
CUMBRIA**

**Reference - WDS/05/9362/REP01**

**Date - 04/08/2025**

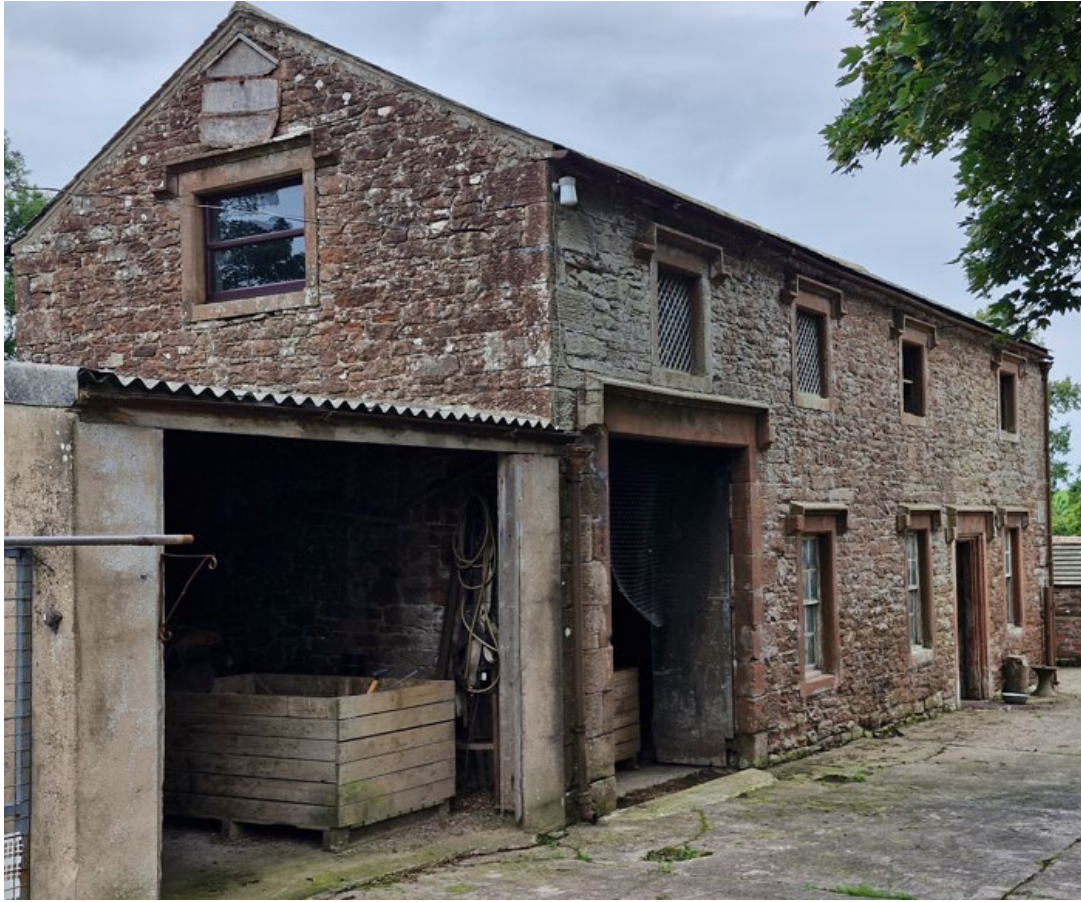
PHOTO 01 VIEW ON FRONT ELEVATION

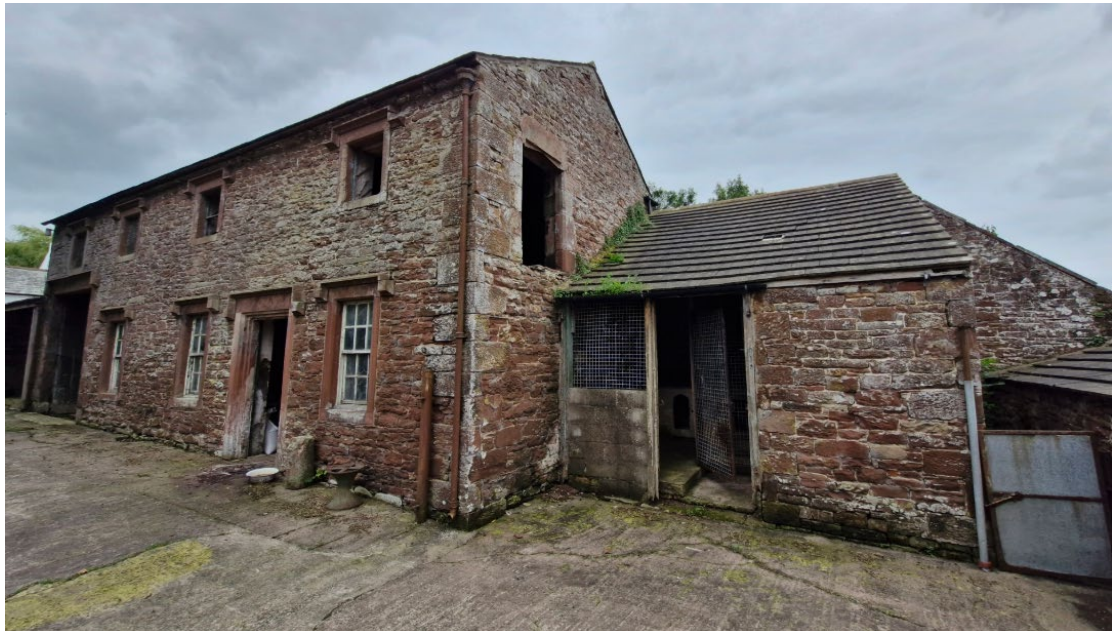
PHOTO 02 VIEW ON RIGHT HAND GABLE AND EXTENSION

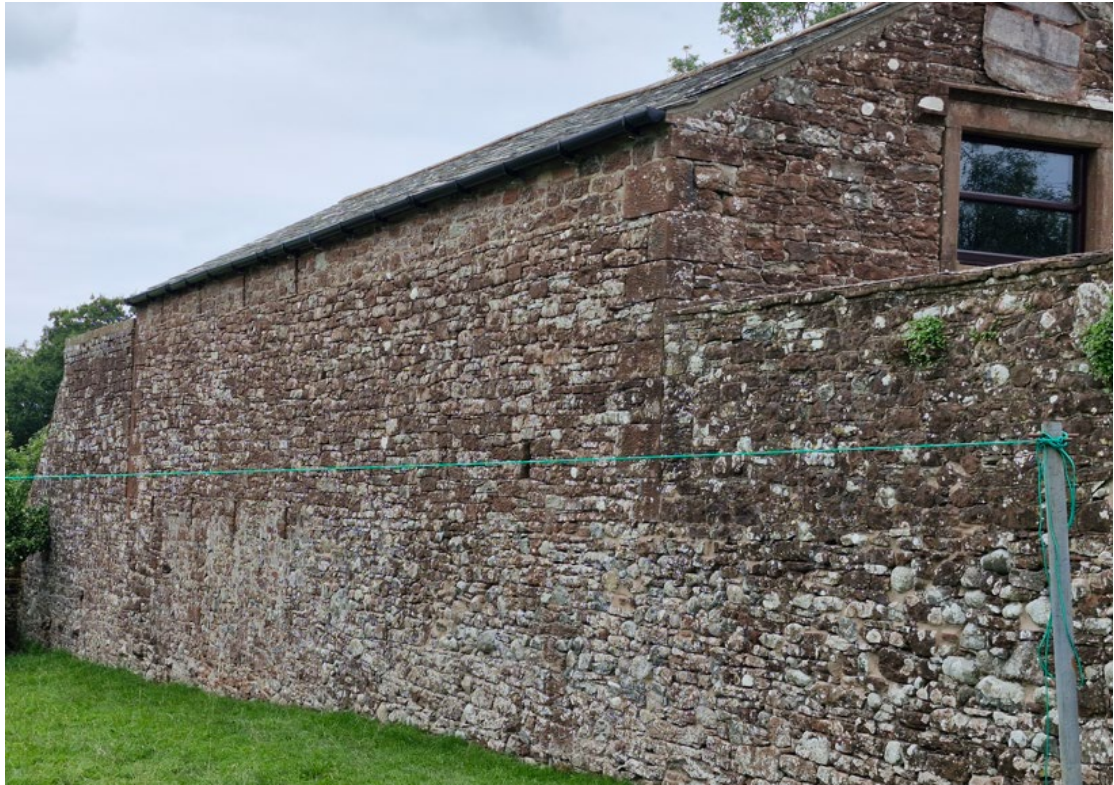
PHOTO 03 VIEW ON REAR ELEVATION
