## Overgate Mealsgate – Statement of Changes due to Structural/Building Regulation issues- February 2025

Whilst permission was obtained for various works during the construction a greater understanding was gained revealing structural issues or building issues conflicting with current building regulations which required some minor amendments: -

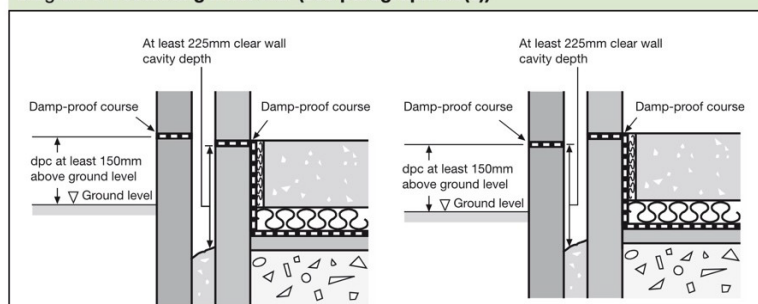
Diagram 9 Protecting inner leaf (see paragraph 5.5(c))

With this trial holes were excavated against the main house walls which identified the walls to be founded at a shallow level. Significant underpinning would have been required to facilitate the new ground floor construction. The walls are formed in random stone rubble fill and appeared loose in many locations; local collapse was a real potential should the walls be undermined. The engineers opinion was to lift the floor level to allow the new floor construction to be achieved without undermining the existing structure. In addition in some areas external ground levels were higher than internal floor levels

which would not comply with todays building regulations and lead to damp issues. ( BRegs Document C Para 5.5 – diagram 9 below).

Permission was given to insulate and replace floors and with the above engineers comments, to avoid walls collapsing and to comply with todays building regulations it was necessary to raise the floor slightly in the living room and dining area which also helped with damp issues.

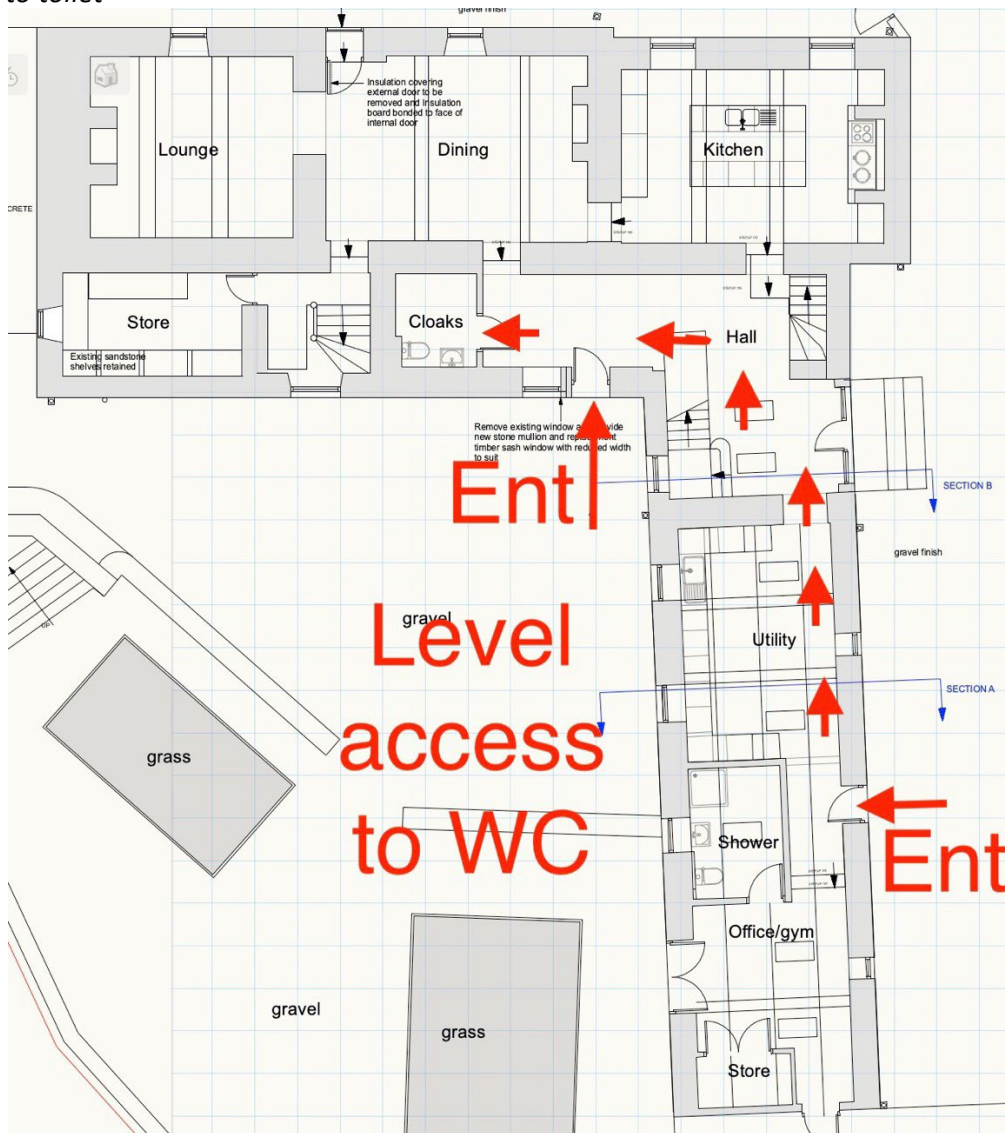
The external level access entrance to the barn and utility area leads into the link building and into the upper ground level of the farmhouse where the accessible toilet is located. Due to existing ground levels this results in external steps to the main entrance and a low floor to ceiling level under the first floor balcony (2.13m).

Level access to rear door and office door leading to level access to toilet

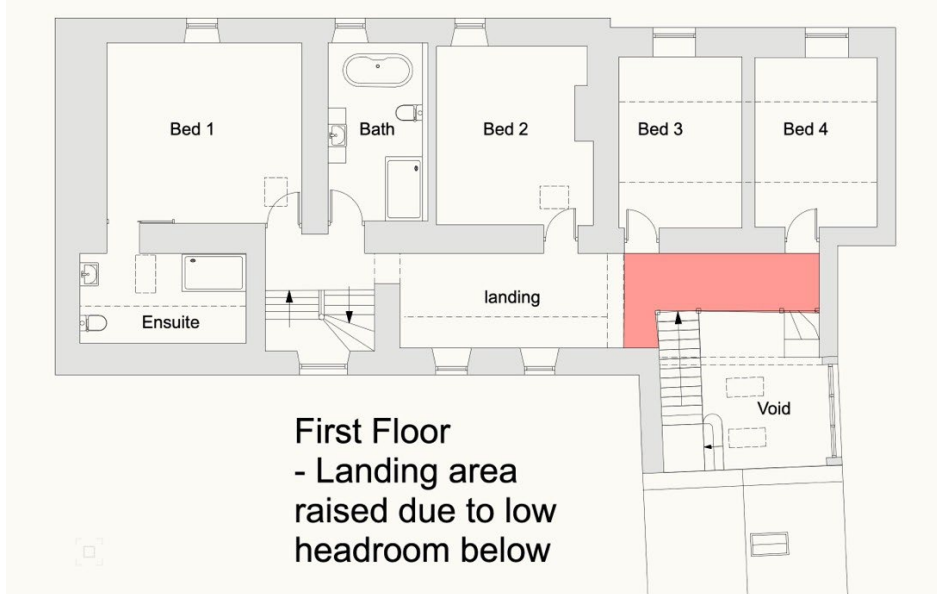
2 - Limited headroom under landing

Approval was given to remove bathroom, wc and stores in the sloping area of roof which had limited headroom to allow a more open plan and brighter landing area however the approval did show a step down on the landing. As noted above headroom at ground floor under the landing is low (2.130m) and a step down on the landing would reduce headroom to less than 2m which would be unacceptably low.

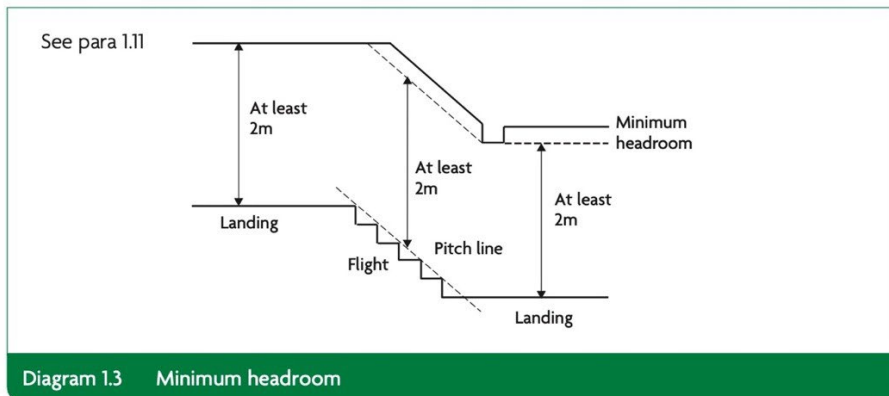
Building regulations no longer give minimum room heights however they do require 2m minimum headroom on a staircase which is an implied minimum height for a room but really only suited to small areas. (B Regs Document K Para 1.1)

1.11 On the access between levels, provide the minimum headroom shown in Diagram 1.3.

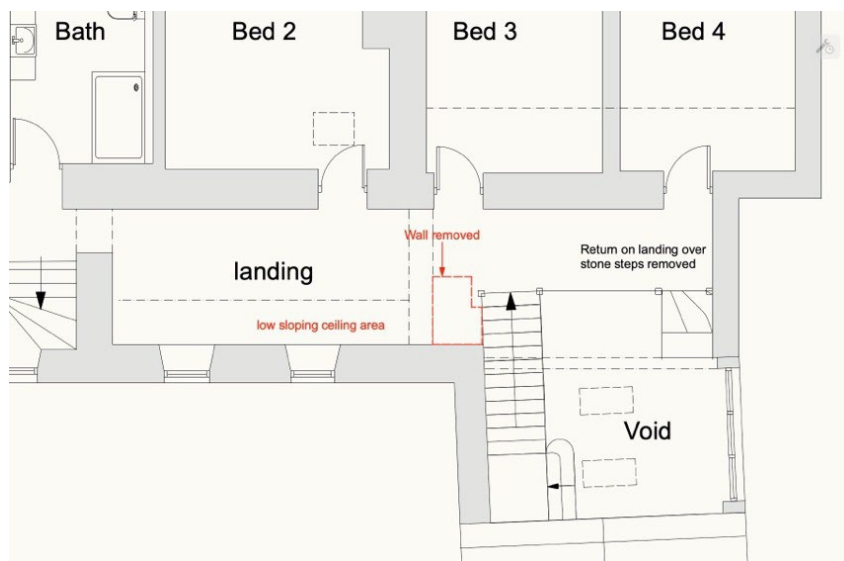
Approval was given to remove a section of wall at ground floor and the formation of a stair cupboard under the stair. This wall also continued up to first floor but was shown retained

The first floor wall to be retained was to be supported on steel beams. The section of the existing wall was plastered, in a low sloping area of roof and provided enclosure to a store.

With the removal of all other bathroom/store walls in this area to provide an lighter/brighter landing area (see photo 1) the non structural wall was removed to continue the open plan theme and not felt to be detrimental providing light at the head of the stair and an open view.

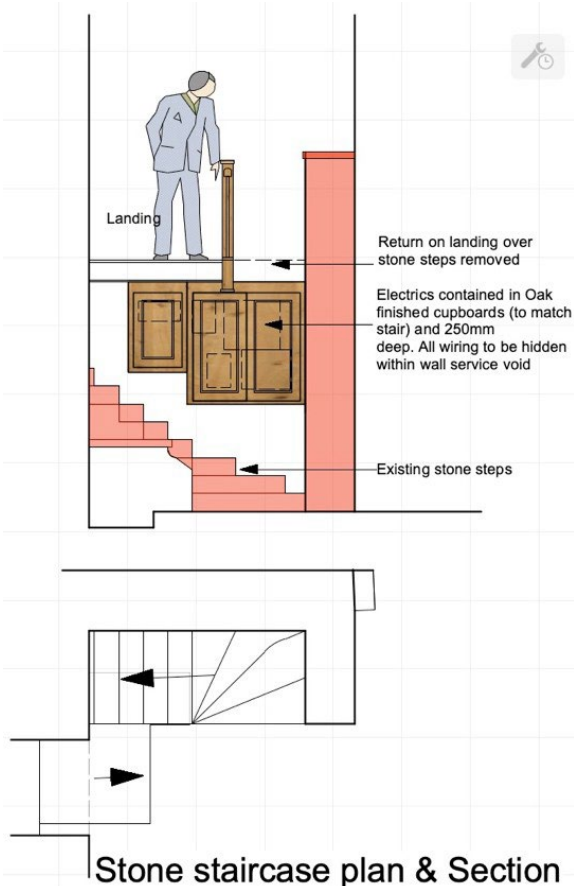
**Stone staircase plan & Section**

The one area not shown was the external section of wall adjacent the stone staircase. This wall however contained the existing electric meter and fuse board to which all circuit wiring returns which originally together with the stair was hidden in a modern partition enclosure with sliding door. It was agreed the feature stone stair should be open to view due to its historical significant and remain a feature in the building. With no wall lining the area of north facing wall is a cold bridge and there was found to be rising damp issues.

Therefore in accordance with BRegs Document C Para 5.10 – diagram 11 the lining of the wall is necessary to prevent damp issues. This has the huge benefit of creating a service void to hide all wiring to and from the existing circuit board. There are further plans to enclose all electrical equipment in a close fitted wall cupboard above the stone stair which will be subject to a further LBC application.

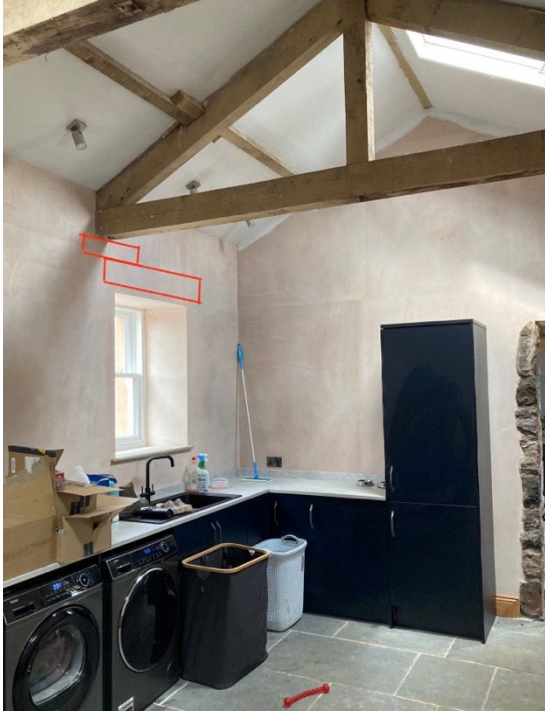
Approval was given to convert the single storey barn to provide a farm office, shower/wc and utility space including the refurbish of the roof slating and replacement of rotten timber roof trusses. The roof was in a poor condition with holes in the roofing due to slate loss or slip. The replacement roof trusses which matched existing sit on pad stones and in some areas are

located above window lintels which dictated the height of the roof.

In addition the original slightly undersized roof rafters needed replacement due to rot with slightly taller rafters specified by the engineer and given approval. The taller rafters also allowed thicker insulation to be incorporated in the roof to reflect current thermal regulations in the building regs. (Building Regs Document L Table 4.2 Limiting U values in existing buildings)

All of the above with an element of levelling of the top of the wall resulted with a slight increase in the eaves height which was made up in stone to match the existing stonework.

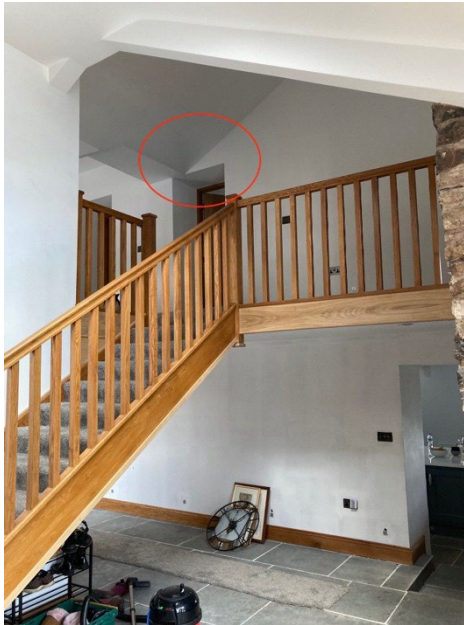
Planning approval was given to infill between the existing farmhouse and the single storey barn. However there was a dimensional error in the original drawn proposals and the infill between the two buildings is slightly wider than originally shown. This has been corrected.

With the development of the engineers steelwork proposals for the link there is a increase in height of a short section of the eaves on the two storey extension however ridge height as been maintained in this area. As can be seen in Illustration 6 the steelwork for the link springs from the head of the door into bed 3 and was kept as low as possible appreciating the sensitive nature of any extension.
